# Geophysical Investigation of Flood Control Levees in the Sacramento-San Joaquin Estuary, CA.

FERRIZ, Horacio, SANDHU, Resham, LOOGMAN, Ashley, GALBREATH, Stacey, Department of Physics and Geology, California State University, Stanislaus, One University Circle, Turlock, CA 95382

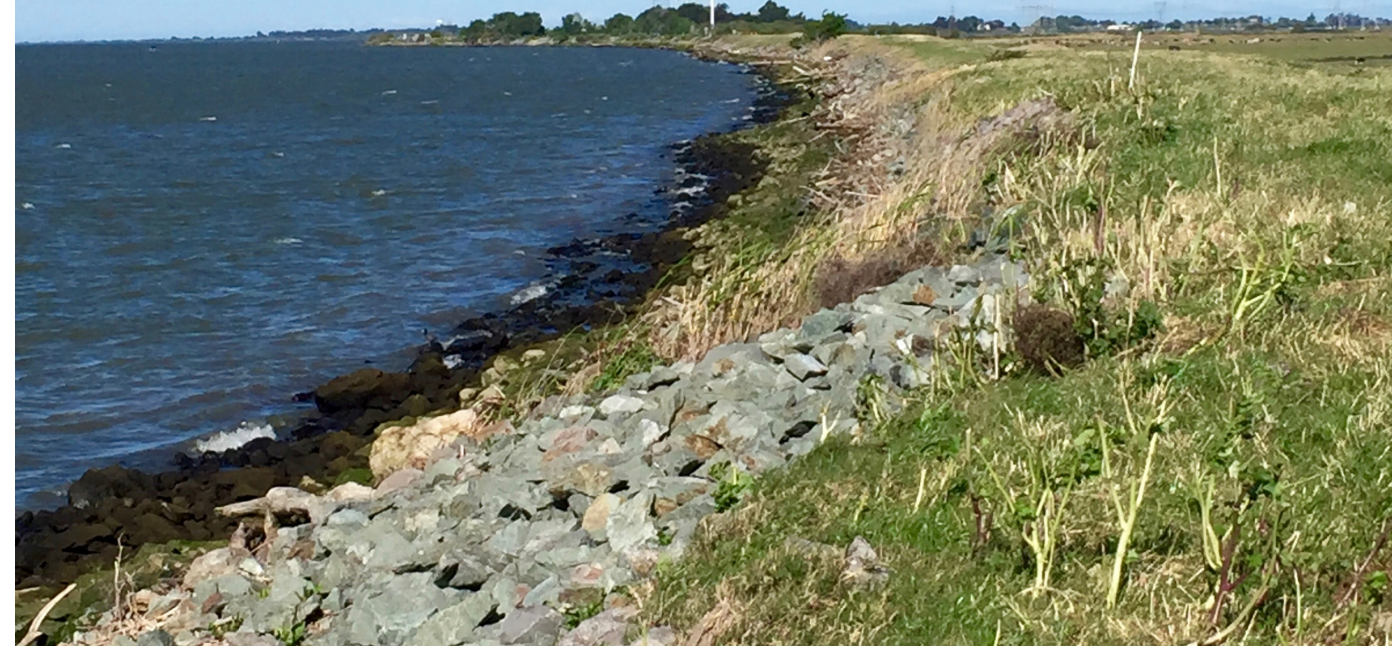
In comparison, below, the ideal construction of a flood control levee complete with a clay core to inhibit the seepage of water.
