RVR Meander to Assess Snowslide Canyon Creek

Richard Alcalá, Seema Shah-Fairbank Ph. D.

California State Polytechnic University Pomona, Civil Engineering Department

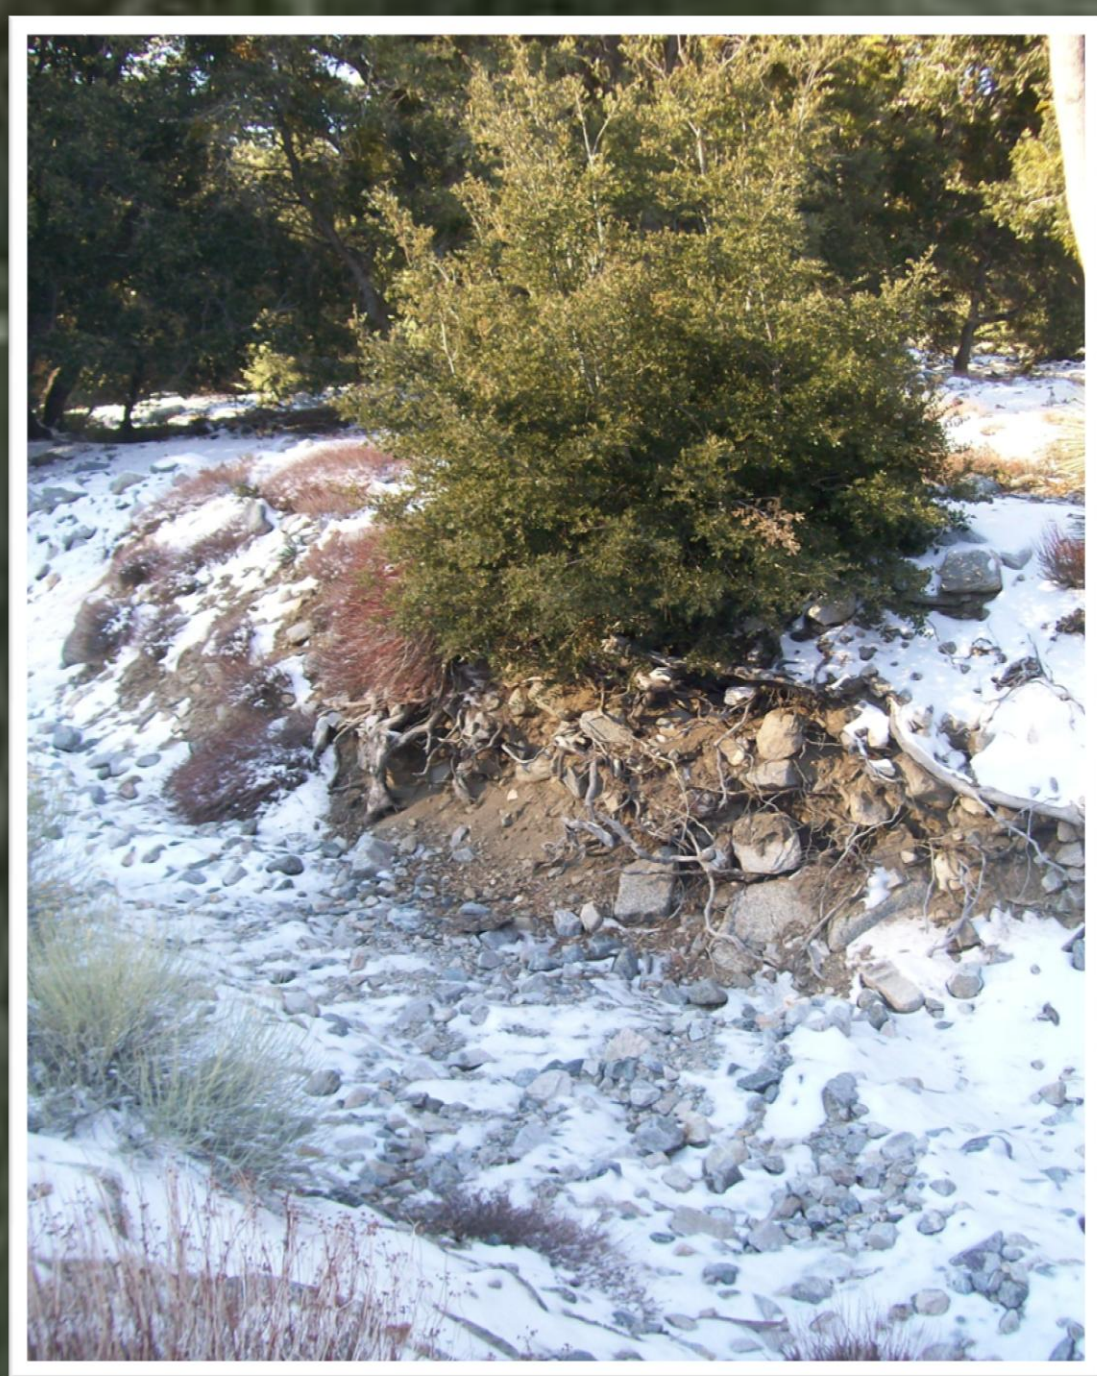
Figure 1: Bank instability/channel migration

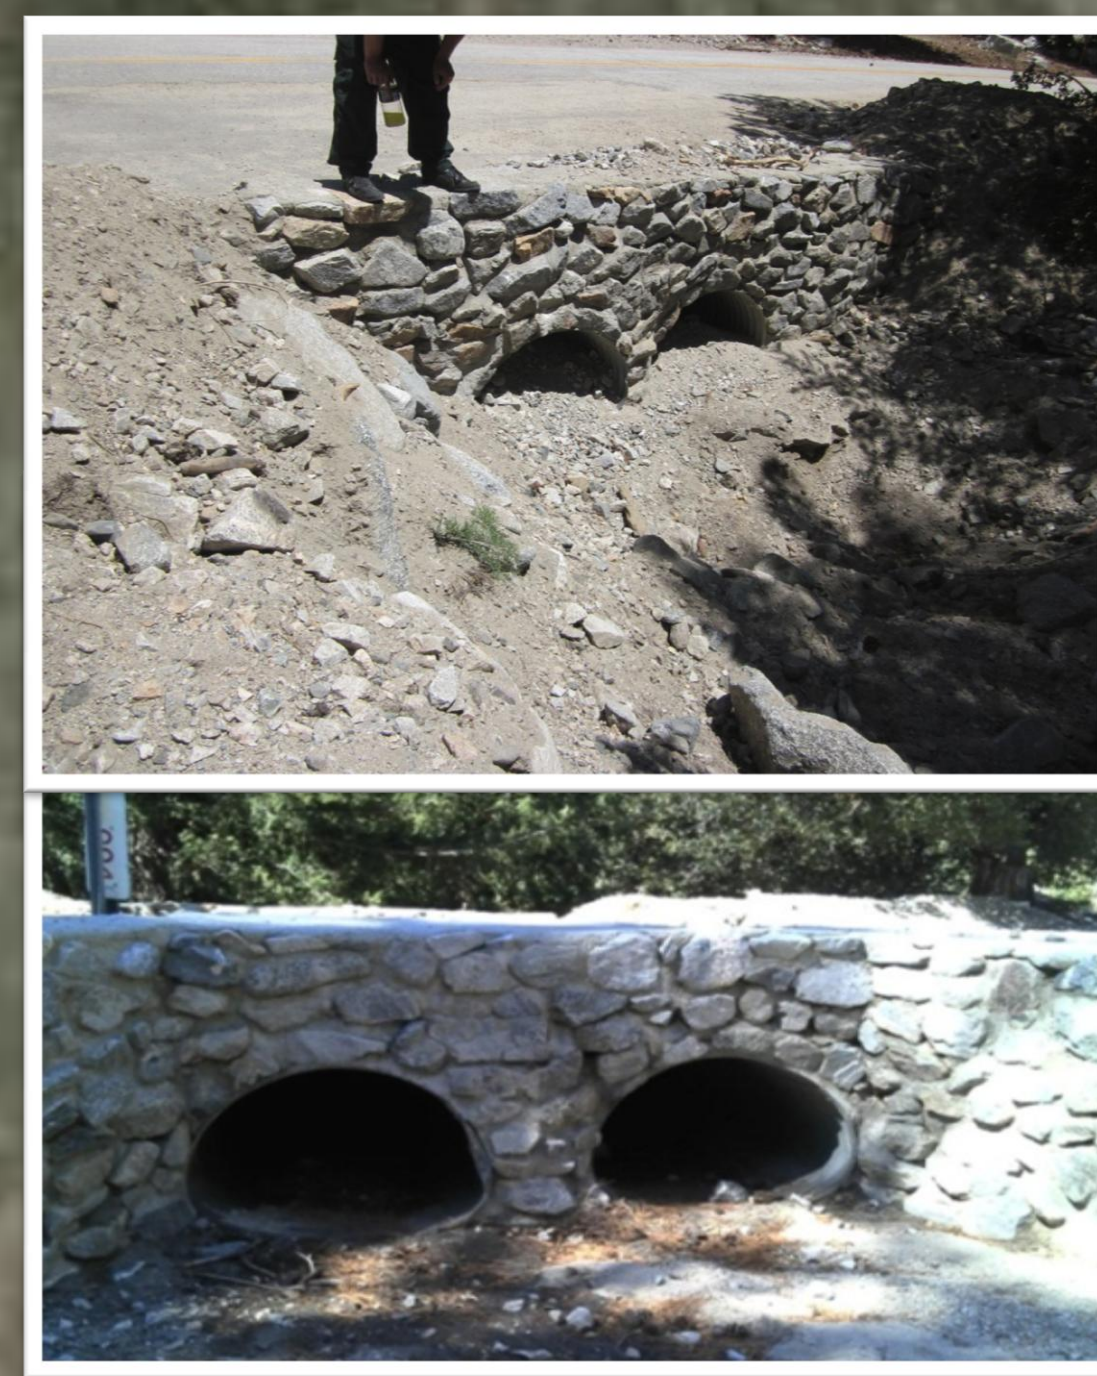
Figure 2: Culvert at point C showing excess erosion and deposition of sediment

- Evaluate future Snowslide Canyon Creek migration within the Crystal Lake Campground
- Determine potential of changes in planform which would result in damage to roads/walkways and in-stream structures (Figure 2)
- Perform background analysis and research on the processes leading to the natural migration of meandering channels^{1,2}

- Snowslide Canyon Creek is an ephemeral, gravel bed stream located within the Crystal Lake Campground in Azusa, California
- During rain events, creek deposit larges amounts of sediment (gravel-Boulders, figure 2) within campground causing camp closures and damages to buildings³

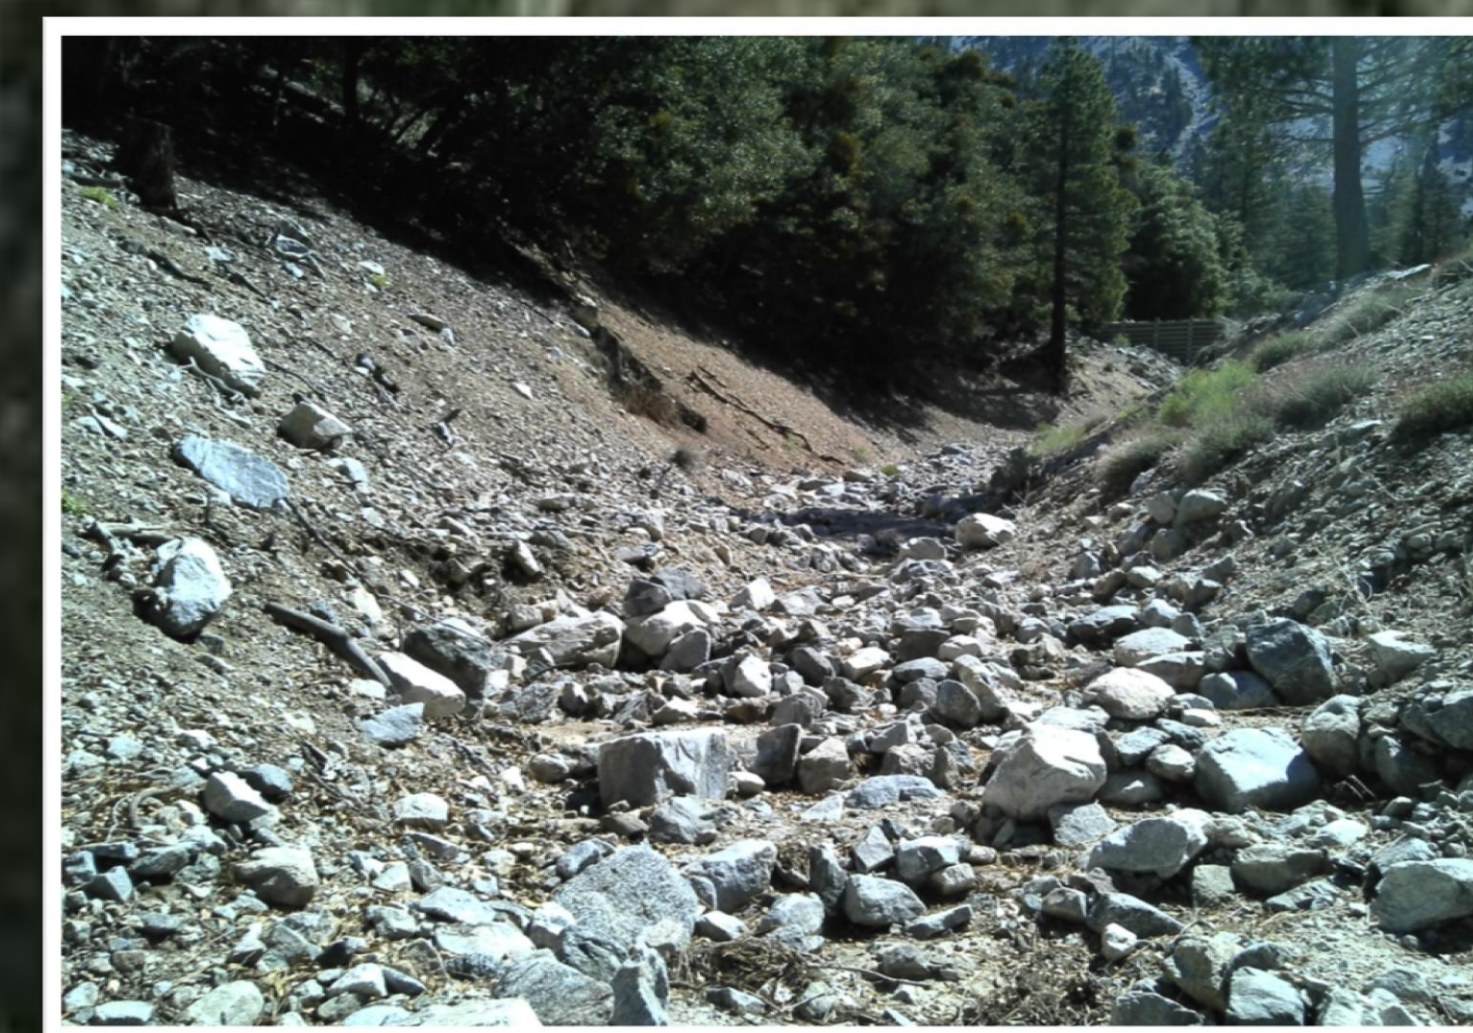
Figure 3: Point A down stream from a debris basin and left of roadway

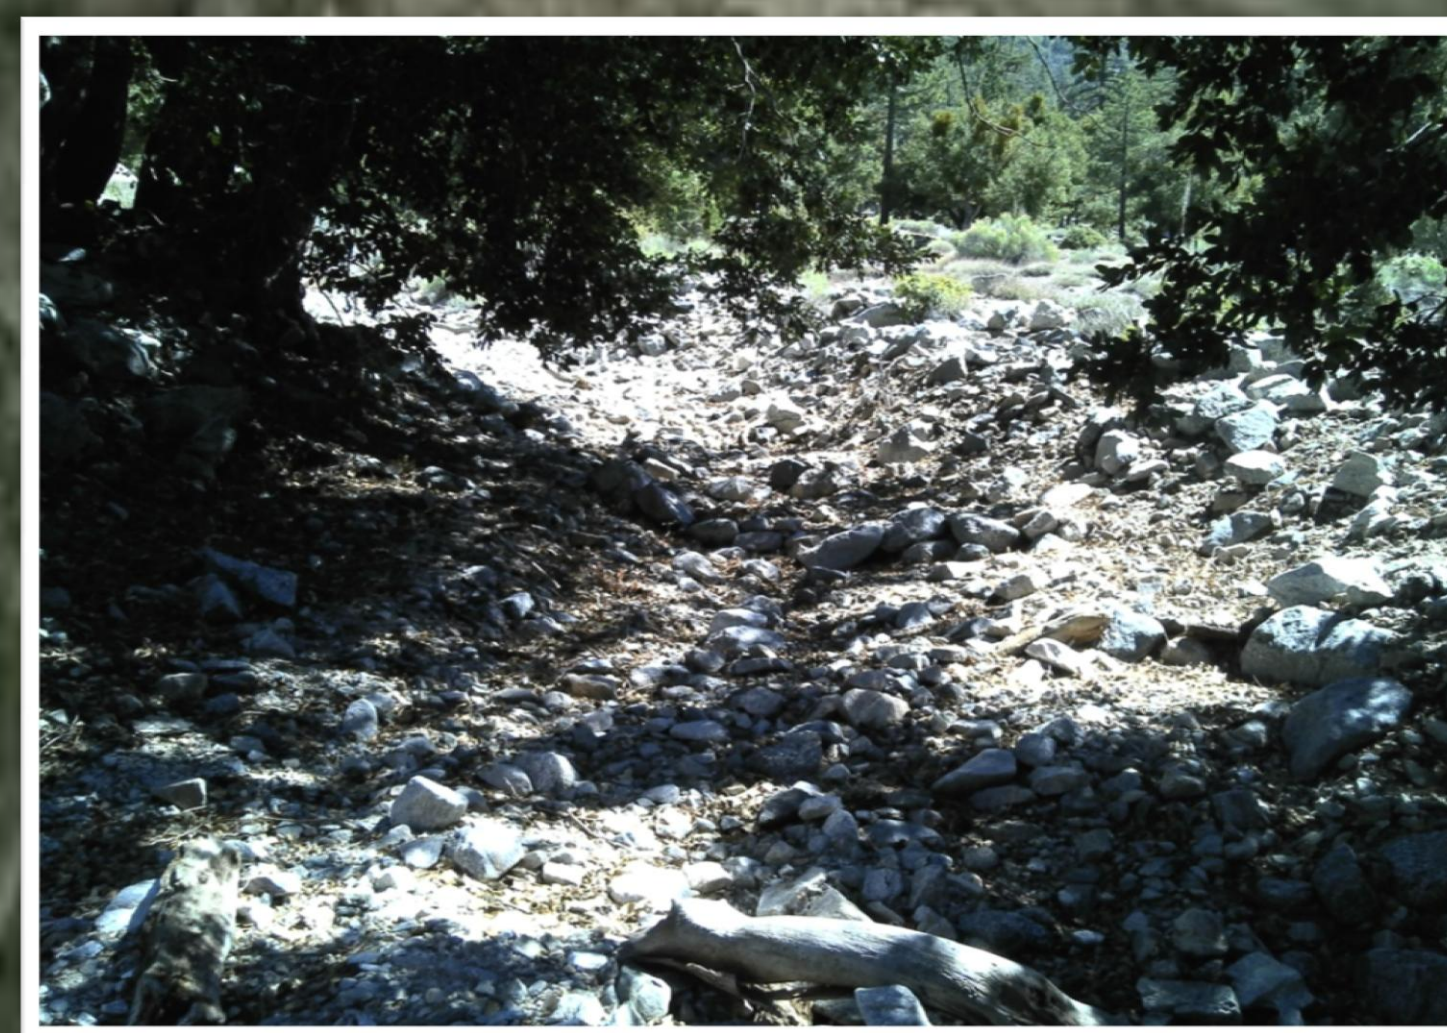
Figure 4: Point B near campsite locations

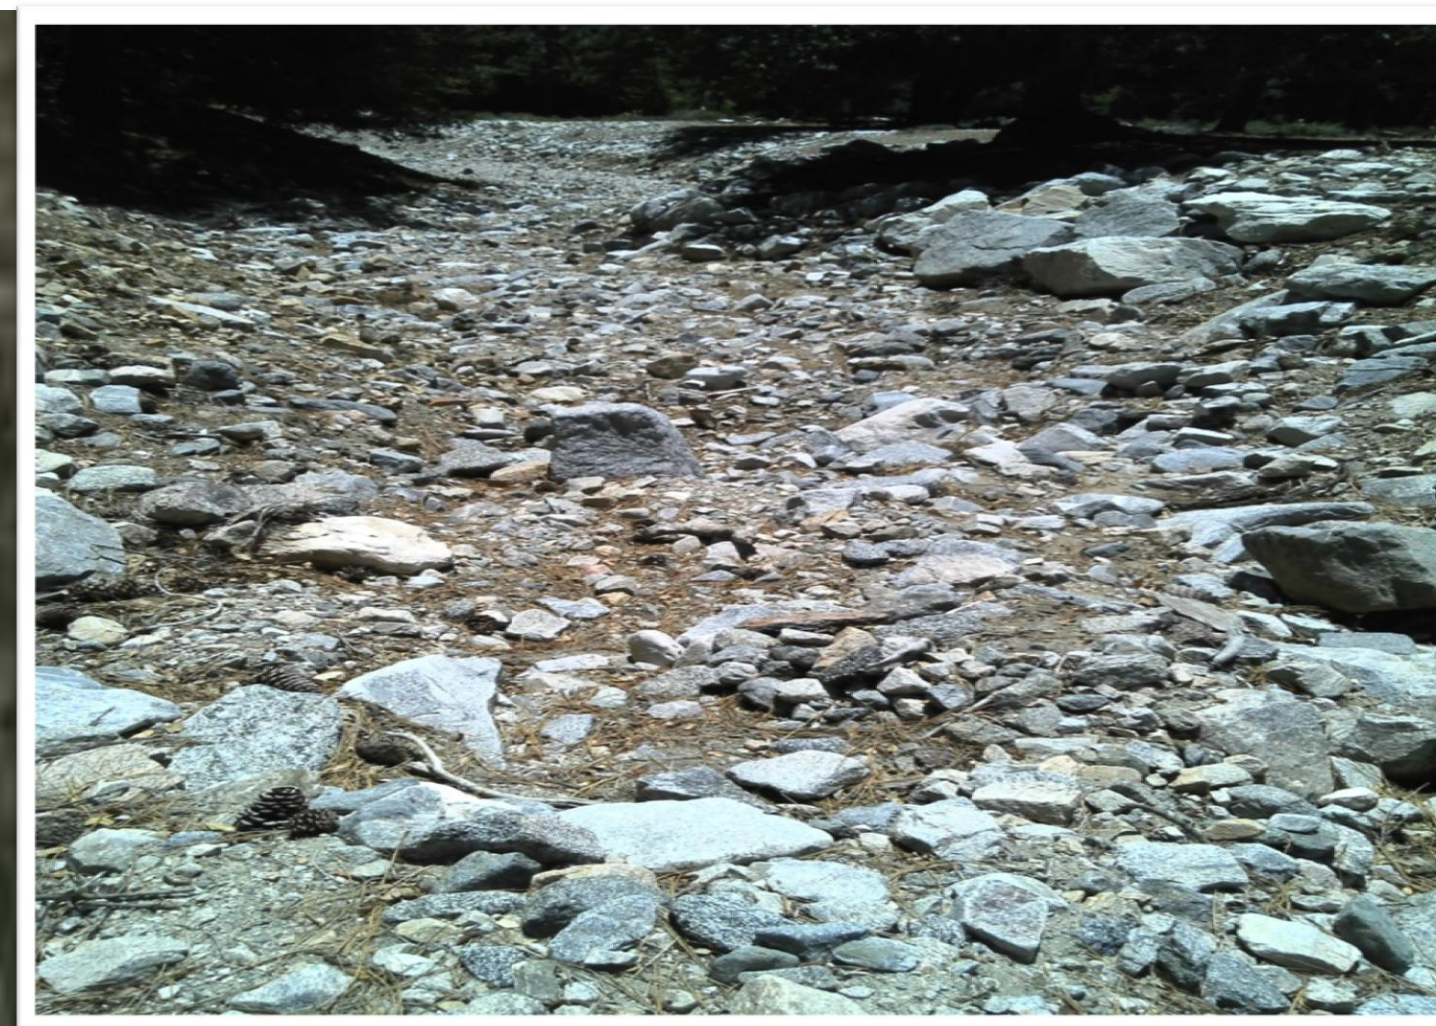
Figure 5: Point D left of roadway

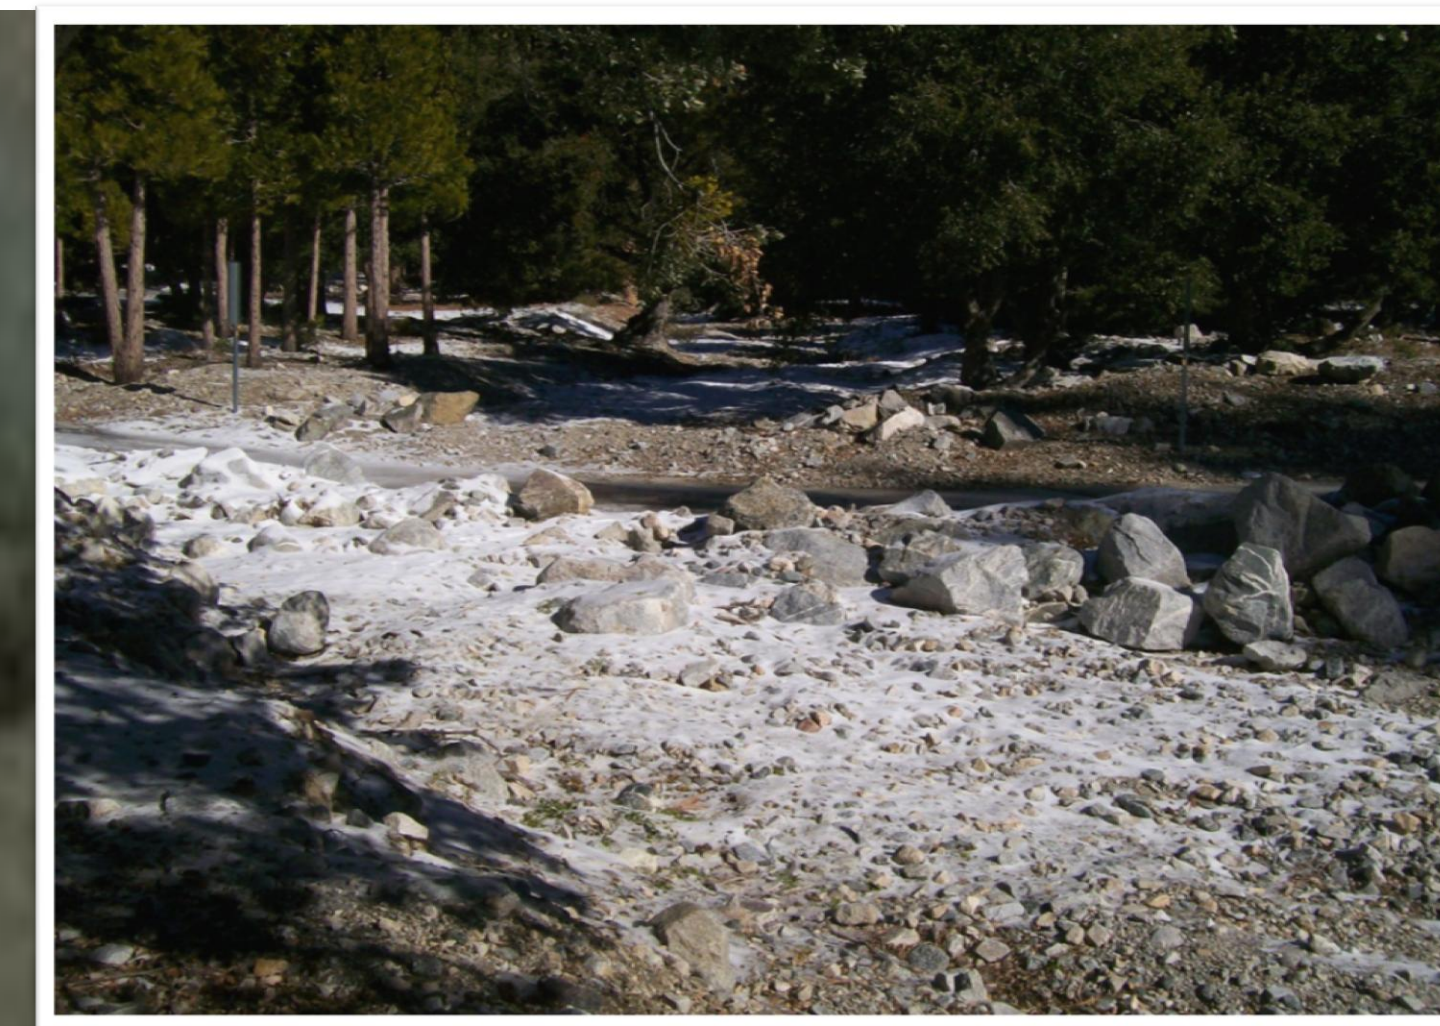
Figure 6: Point E low flow crossing

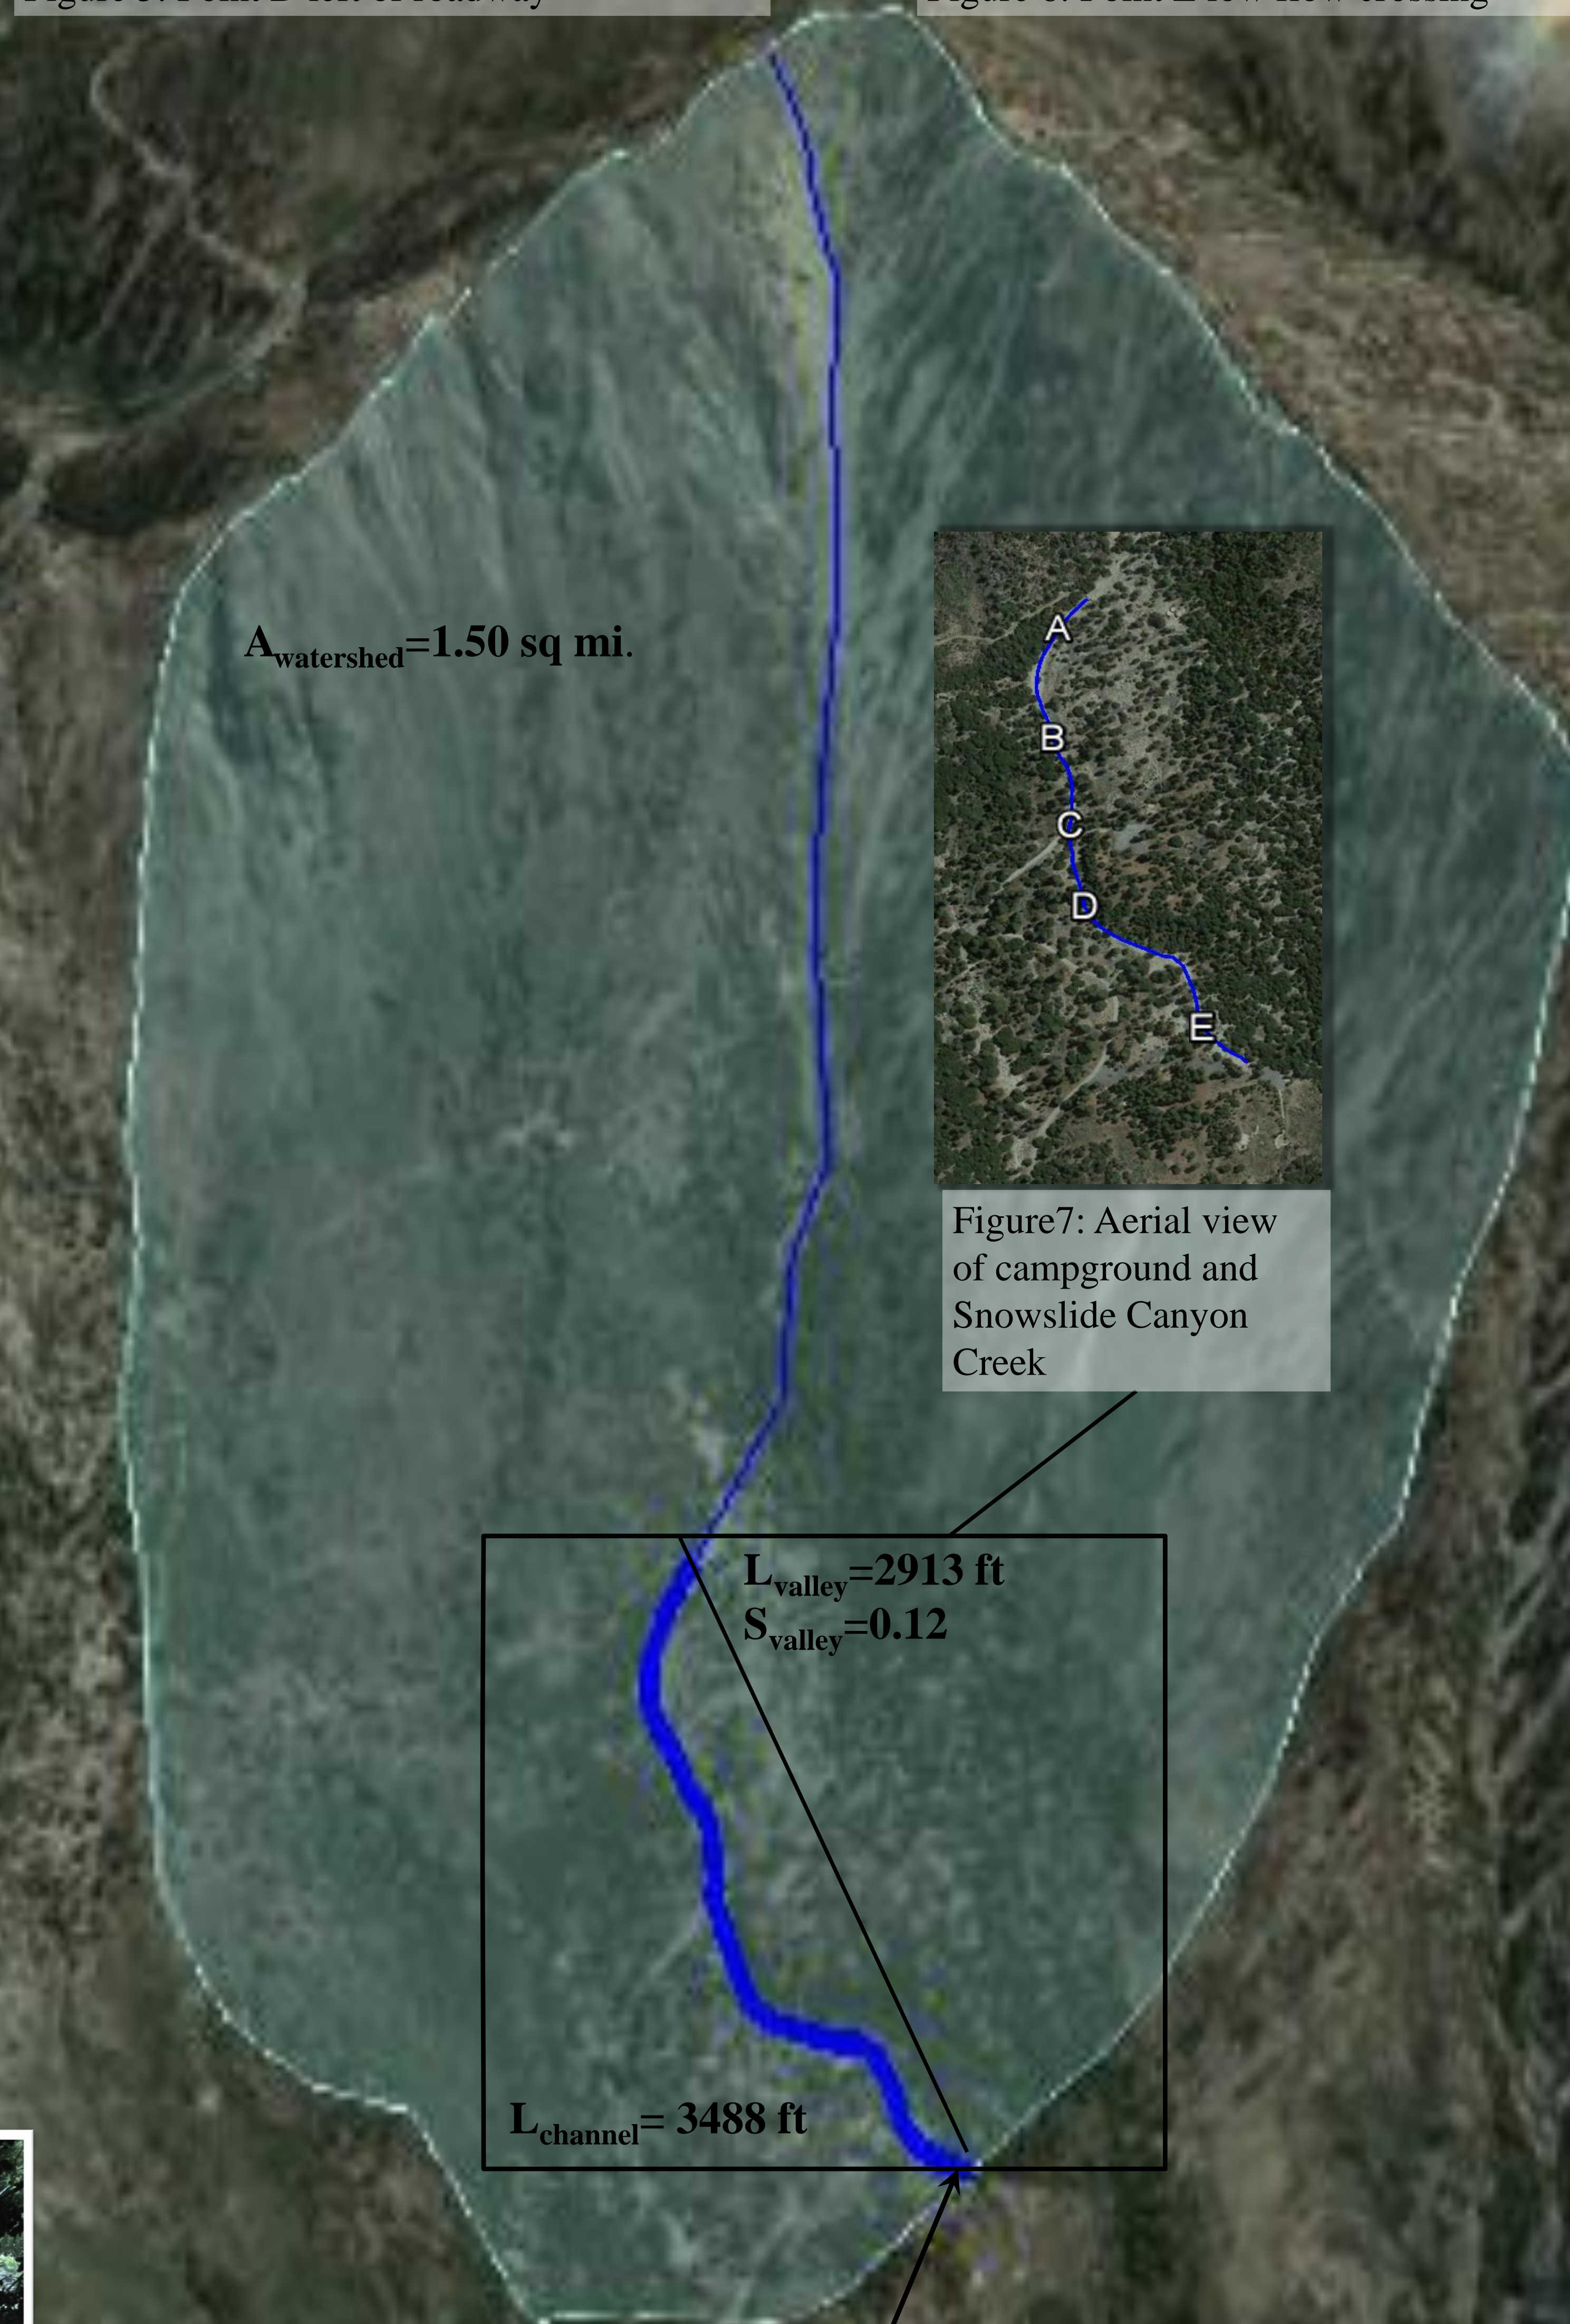
Figure 7: Aerial view of campground and Snowslide Canyon Creek

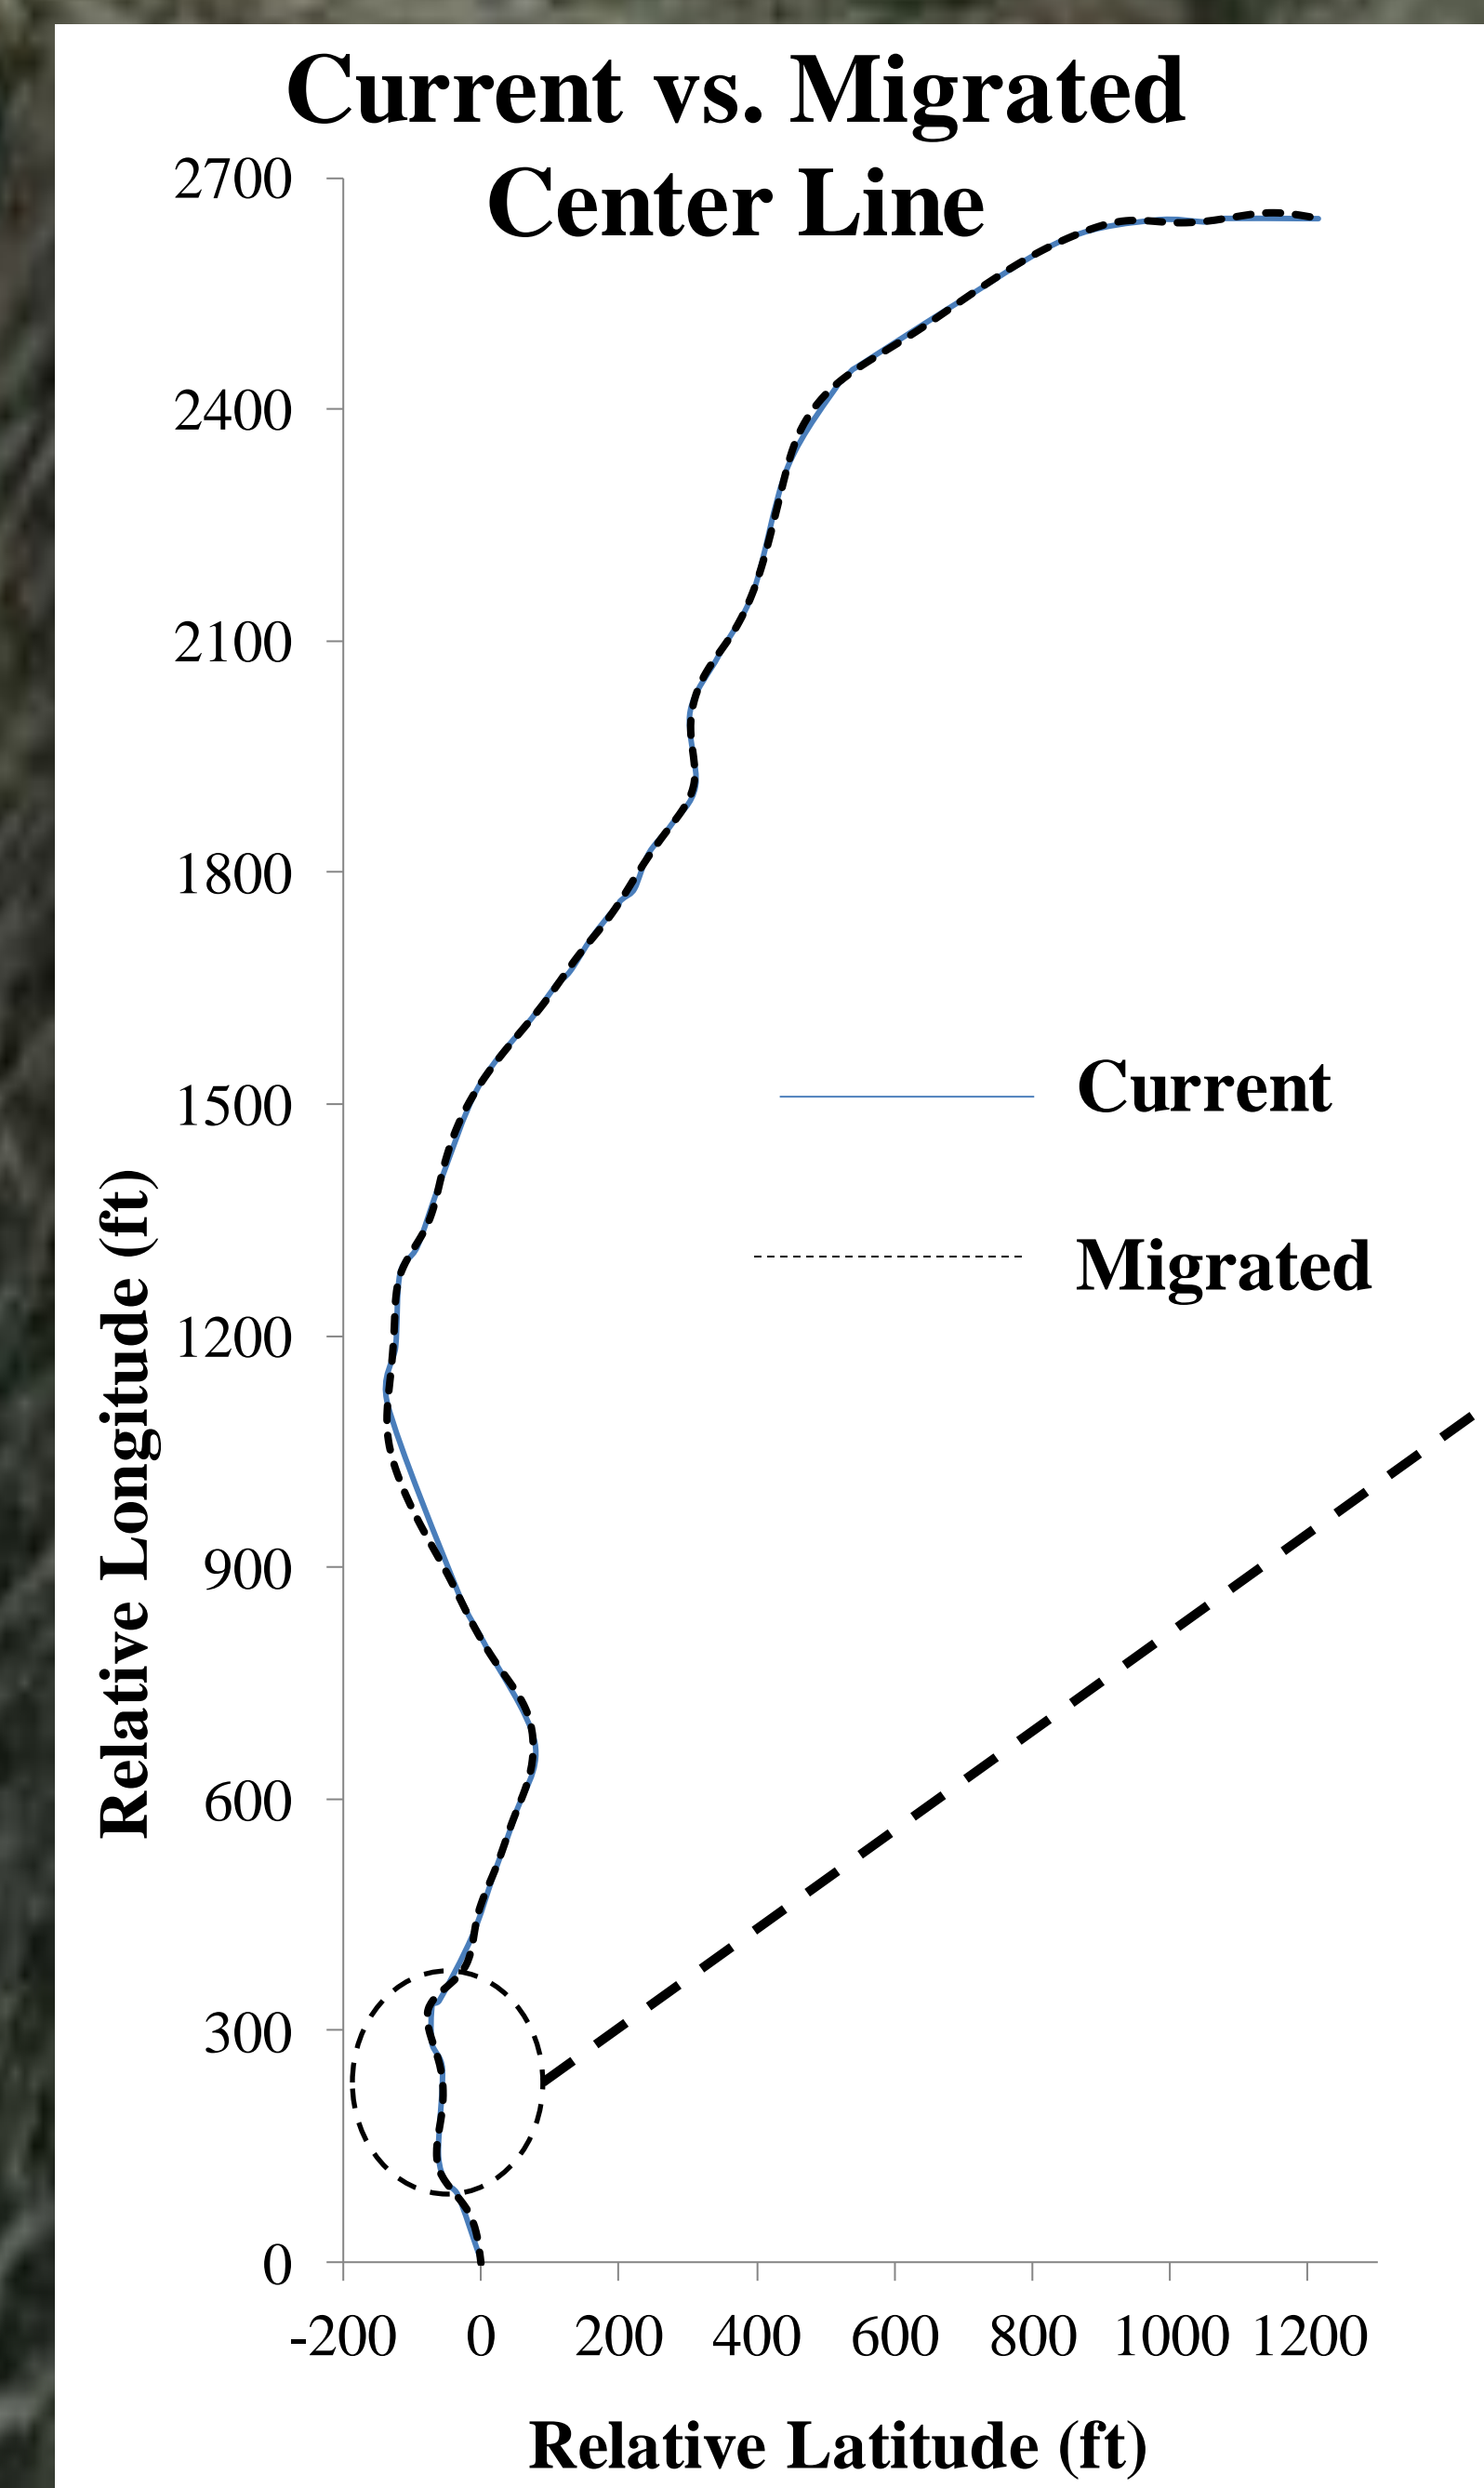
Figure 9: Migrated centerlines versus current centerline

- Model channel migration/meandering patterns
- Utilizes a dimensionless migration rate coefficient that predicts stream trajectories by applying an bank erosion coefficient with the near-bank excess velocity to simulate hydraulic erosion to predict migration of stream centerline after "X" amount of years

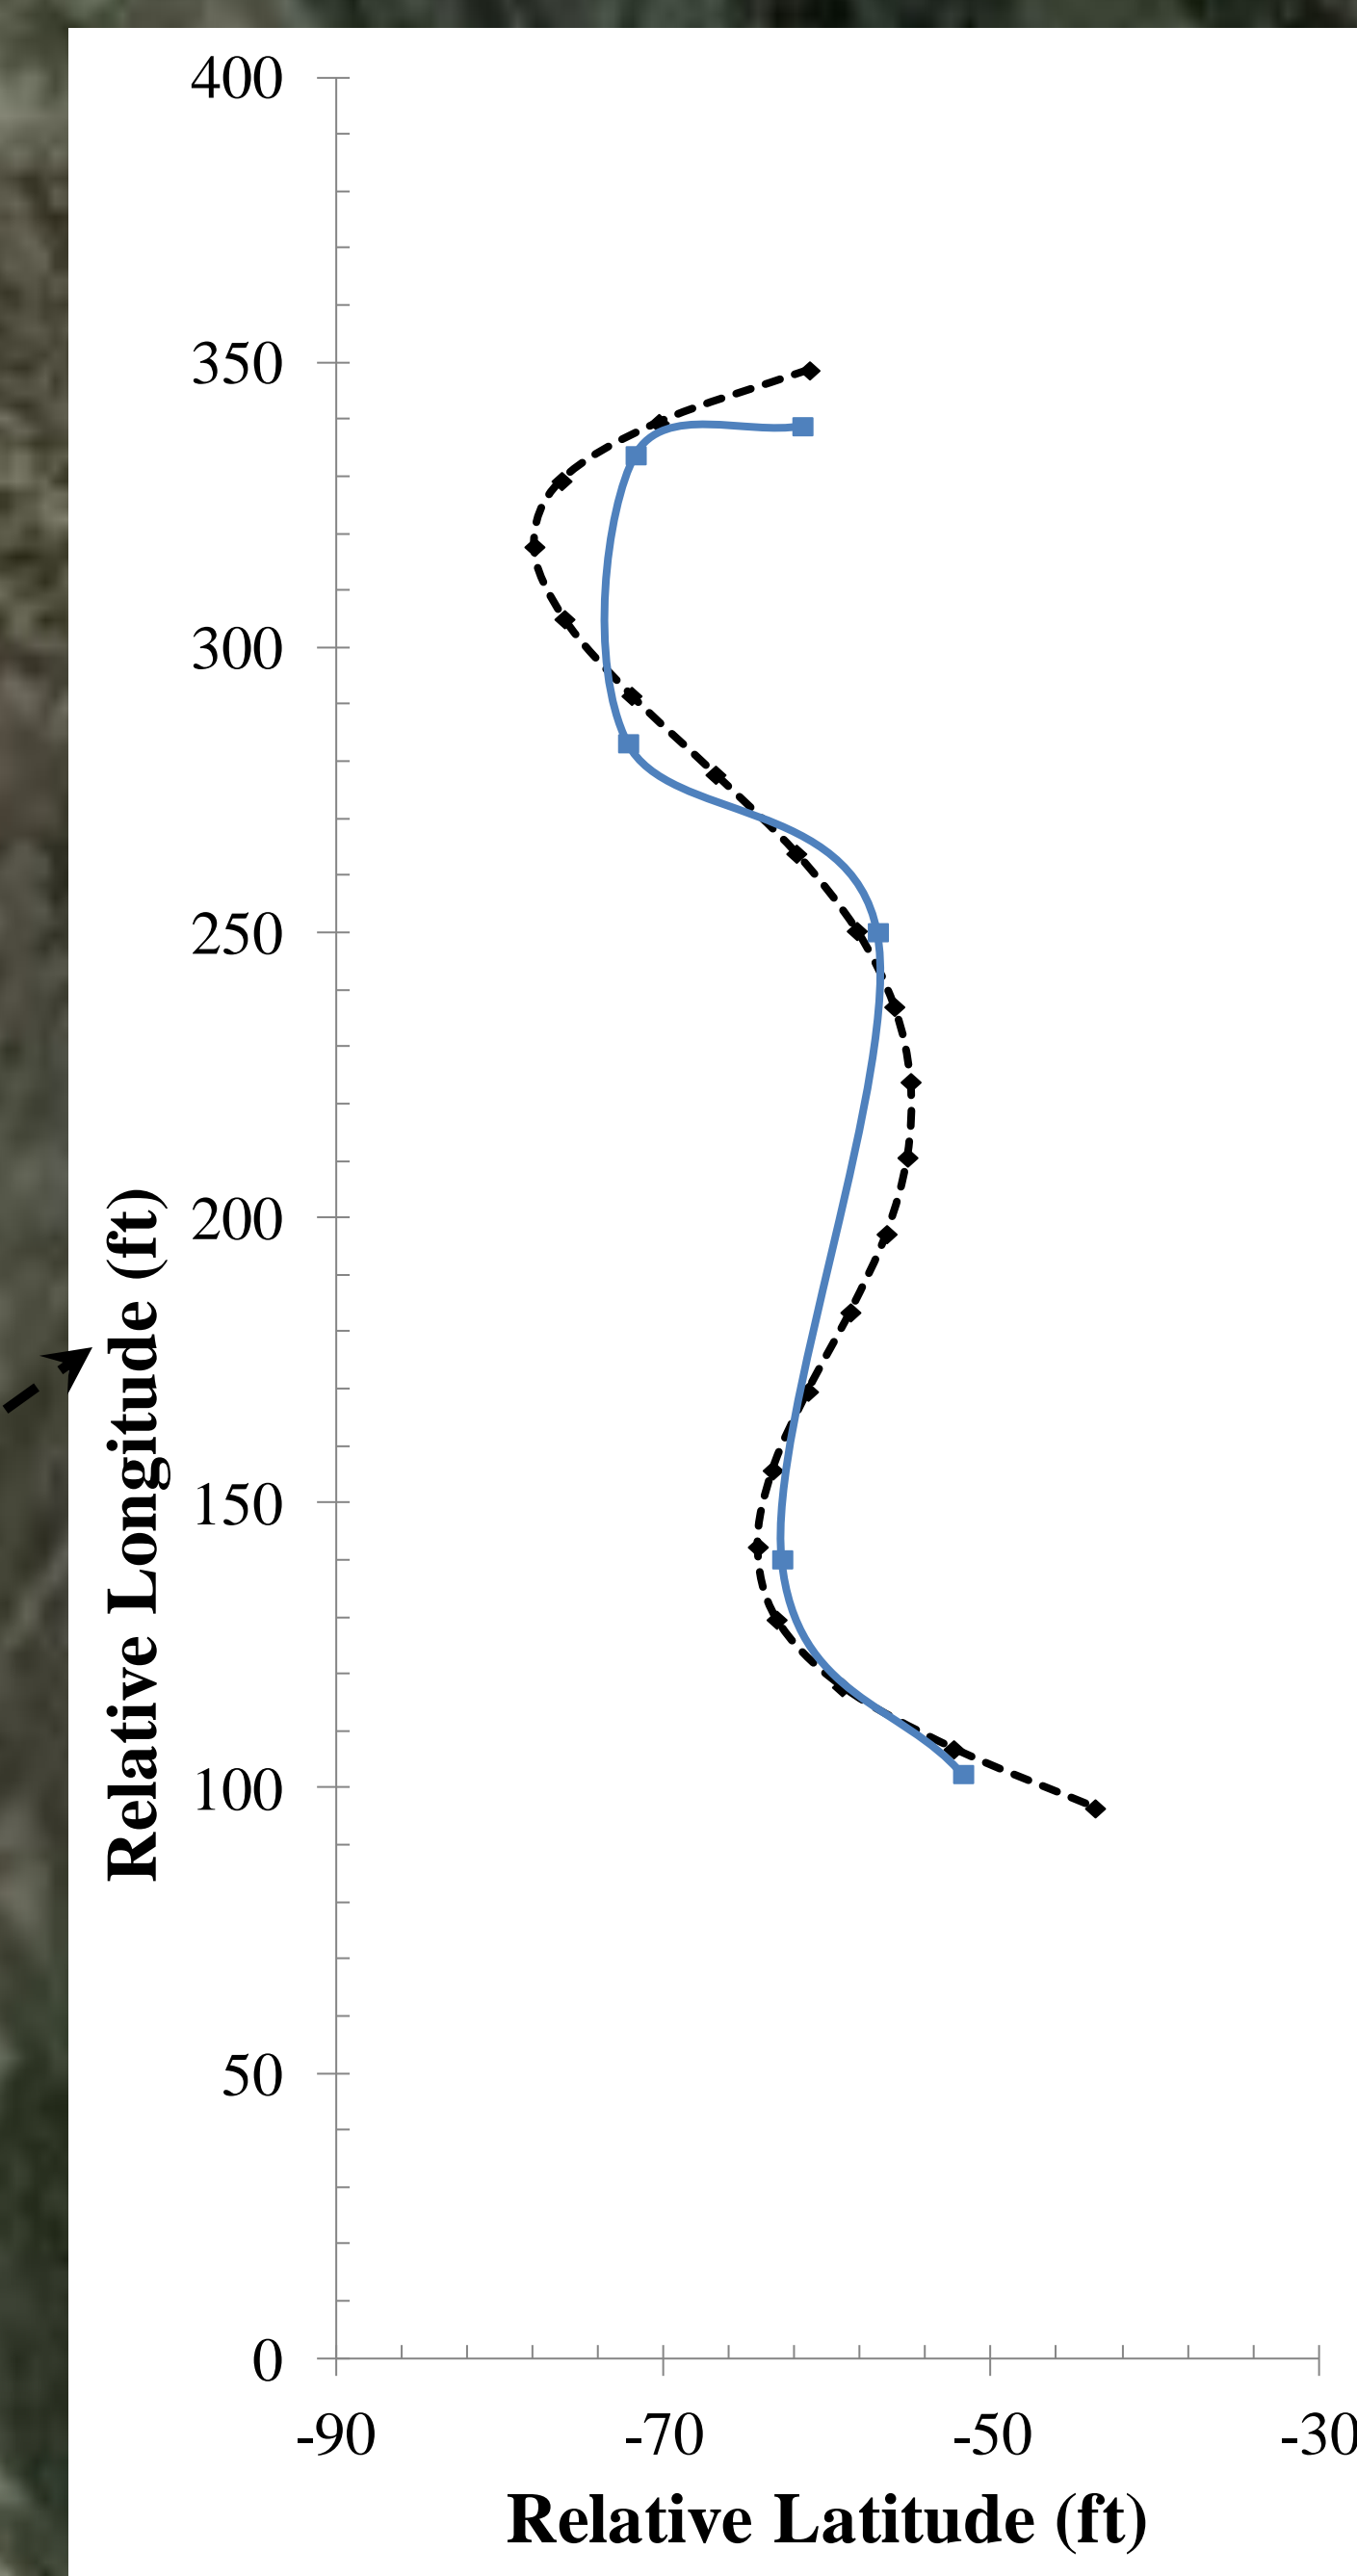
Figure 10: Area of interest, significant migration at meanders

- Using RVR Meander to determine the movement of Snowslide Canyon creek showed migration at some locations ranging 10-20 feet (figure 10)
- Further research will be conducted to determine the stability of the banks and the sediment yield produced by erosion during various storm events
